Characteristic of Safety Recovery Zone and Roadside Hazard Cases in Malaysia Road: A Review

Abstract- The increasing number of highway crashes and the rising rate of fatality on run-off-road accidents has alarmed institutions to introduce design guidelines, evaluate their outcomes and improve the guidelines accordingly. This paper presents a case study on some of the existing roadside hazards in Malaysia, their impact to motorists, and reviews the current related provisions in the published design guidelines. Observations and in-depth study were made to the selected existing roadside hazards and assess their compliance to the available design guidelines and recommend improvement to some areas. The scope of the study covers on roadside trees, lighting and signboard poles, drainage structures, kerbs and safety barriers. The previously planted trees of less than 100 millimetres diameter within the clear zone of 9 and 6 meters to rural and urban roads respectively have grown in size to more than 500 mm diameters over 15 years, and today they have become hazards and causing deaths or serious injuries to passengers. The lighting and signboard poles installed near to the travel lane have

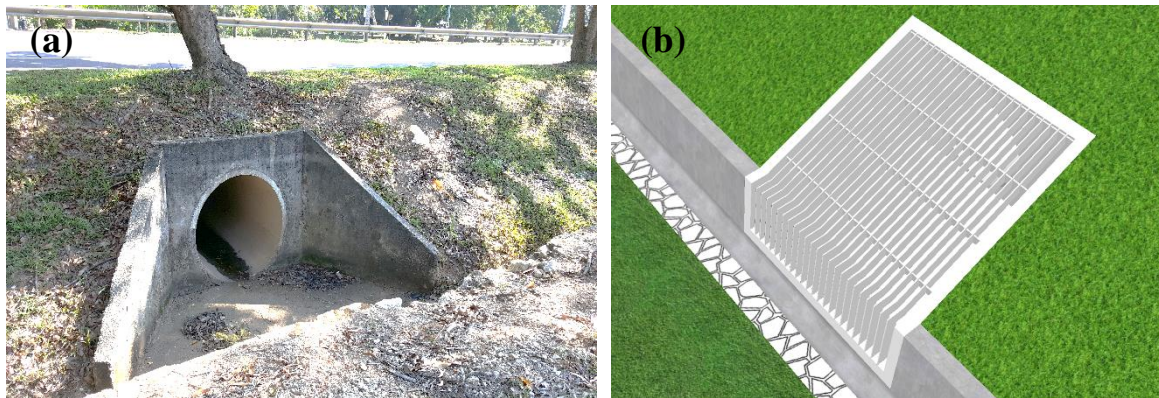
Most of the culverts in Malaysia are having inlet and outlet without metal grating cover as shown in Figure 4 (a). The projection of the concrete head and wing walls above ground surface may cause vehicle to be airborne upon striking. In building-up inlet and outlet as a traversable fore-slope, all culverts inlets and outlets shall be designed to intercept with the roadways embankments and flushed with metal gratings [3, 27].

Figure 4: (a) Concrete culvert at km 5 Gambang-Kuantan highway; (b) Proposed modification to the culvert for (a).

It is proposed that the existing culvert inlet and outlet head walls constructed within the roadside safety recovery zone corridor, the wing wall to be modified as shown in Figure 4 (b). The metal screen serves two functions, namely for screening the debris and the surface is traversable by skidding vehicle for in an attempt to recover back to the travel lane. The metal blade is set to be vertical to minimise debris clinging to the grill and affecting the proper flow of the discharge. As shown in the detail, the selected design is 12 mm plate thickness spaced at 100 mm centres. Both wing walls are set straight instead of at an angle with the direction of storm water flow to prevent entry of eroded earth into the culvert.

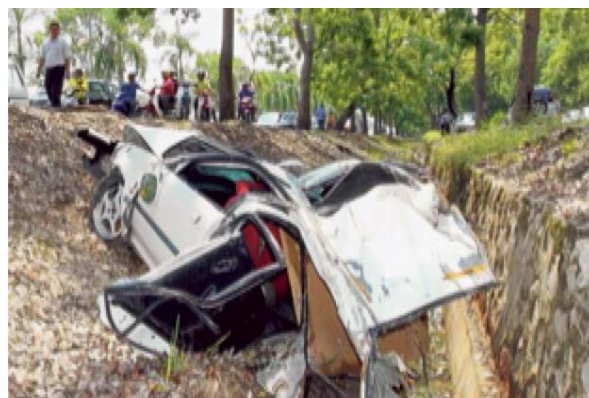
Figure 5 shows skidded car where the driver could not control the car due to steep roadside slope of 1V:1H against the good design practise of 1V:4H the limit for traversable slope and hitting the drain's hard rubble pitching wall and bounced back causing three passengers died and one badly injured. Should the one sided rubble line wall was replaced with turfed earth, the downslope 1V:1H embankment was built with the study recommended new slope of 1V:4H, even if skidded, there was a possibility the passengers may survived from death and suffered injuries only.

Figure 5: Fatal Accident at Roadside Drain (Source: Kosmo, 10 December 2015)

If the roadside tree and the drain were positioned outside the study recommended safety recovery corridor, the passengers may survive both deaths and injuries. The tragedy has given evident that the drain design is not forgiving and need to be reconstructed with a new design. It is recommended that the drain to be reconstructed with a new design by applying the design concept recommended by the Malaysian standard as shown in Figure 8 (a). The redesign cross-section with enhanced safety of the highway and the sling road are shown in Figure 6 (a) and (b). The discharge capacity of swale is the combination of on the surface capacity, the perforated conduit volume and the interstices of sand and gravel. The volume of runoff to be served is minimal i.e. it is between the centre lines of the highway and sling roads about 20 meters width.

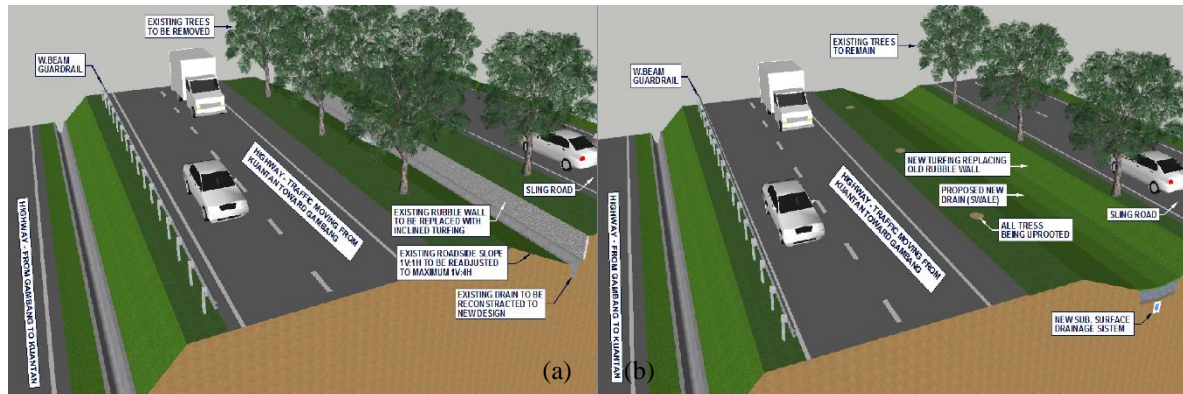
Figure 6: (a) Proposed reconstruction to the site shown in Figure 4; (b) Proposed design upgrade to the existing road shown in Figure 4

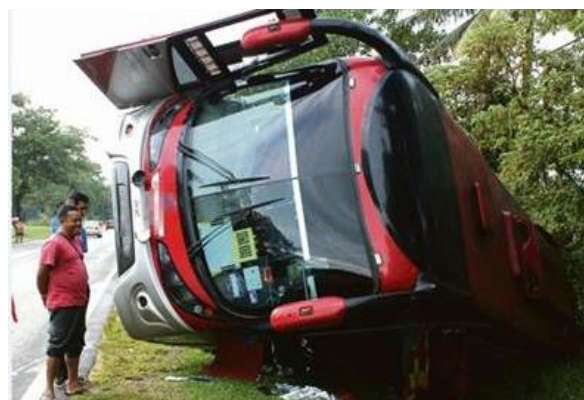
Figure 7, shows a bus skidded into roadside drain located at less than 2 meters away from the travel lane. The bus was avoiding collision from the oncoming car encroaching its lane, but unfortunately the roadside drain is too near to travel lane causing the bus has no space for traversing back to the carriageway. The tragedy evident that all drain to be built away from safety recovery zone corridor in order to ensure motorists safety. If placing drain outside safety corridor zone is unavoidable, the chosen type of drain shall be of traversable type, similar to the previous case employing swale design concept as shown in Figure 8 (a). The similar drain if located at the back-slope, apply cross-sectional design shown Figure 8 (b).

Figure 7: A bus flip over at roadside drain (Source: Ammboi, 20 October 2013)

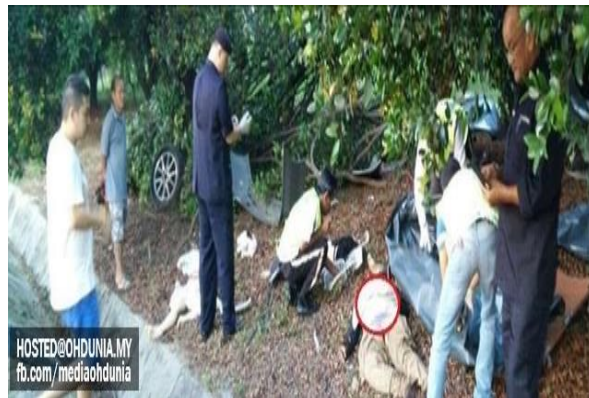
Poorly designed kerbs causing damages upon collision to tyre sidewalls, wheel alignment, sometimes burst and may lead to fatal accidents on prolonged usage. Straying off from travel lane, wheel contact with kerbs could cause a vehicle to airborne and overturn. The ‘forgiving’ type kerb known as ‘mountable kerb’ is one of the two classes of kerbs recommended for application in design by the Malaysian standard known as *A Guide on Geometric Design of Roads* issued by the Road Engineering Association of Malaysia (REAM) under section 5.4.2 [25]. The other type of kerb recommended by the design standard is known as ‘barrier kerb’, though appear to be small in size but the force on impact with the concrete block may cause fatal accident as in the case shown in Figure 9, the motorcar hit the kerb then airborne killed 4 at kilometer 9.9 Elite highway Subang Jaya. The section 5.4.2 prohibits the use of barrier kerb for expressways or design speeds exceed 70 km/h, and the recommended use in build-up areas adjacent to footpaths with considerable pedestrian traffic. If mountable kerb is applied, the motorcar will rise over the kerb, dissipate part of the impact energy and the subsequent reduced

Figure 9: Fatal accident of a motorcar after hit a kerb. (Source: Ohdunia, 26 July 2015)

impact energy on the roadside may not be fatal but with injuries. In enhancing the road safety campaign, auditing and correcting nationwide roadside kerb can be added to the agenda.

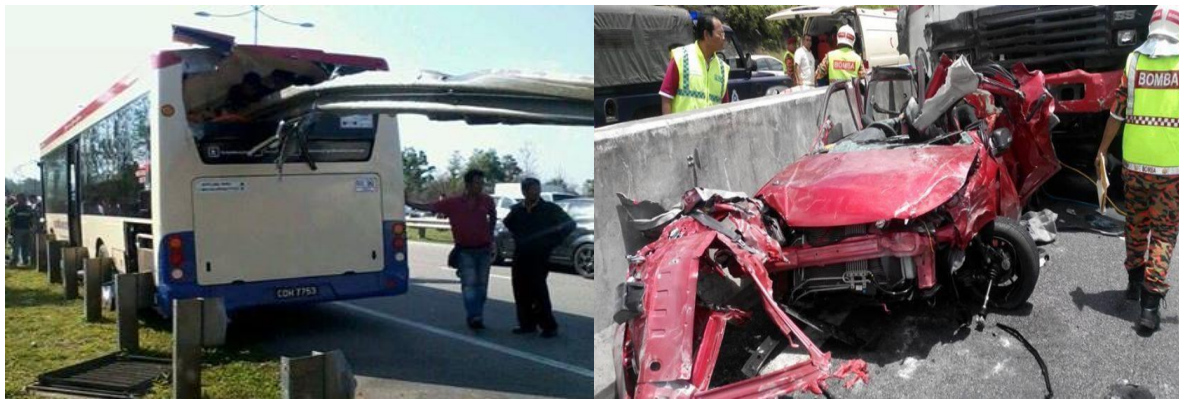
The guardrail itself can be a roadside hazard as shown in Figure 10 (a), an accident at kilometre 13 Jalan Kuantan-Pekan, where the bus front left tyre exploded and then stroked into roadside longitudinal safety barrier has caused the metal beam punctured through the bus [30]. One passenger leg was broken and two passengers were with minor injuries. The reduced risk factor is due to the high elevation of the bus as compared to that of safety barrier height. The safety barrier installed was to shield the row of trees planted within the clear zone of 6 meters. Based on the guidelines, the trees are not permissible to be within the clear zone, and the instruction is a safety barrier is to be provided when the trees cannot be removed or relocated. In this case, the trees to be relocated at the offset of 6 meters from the travel lane due to available, otherwise the trees to be removed.

Figure 10: A metal beam punctured through the Rapid Kuantan Bus; (b) A car crashed into concrete wall
(Source: Melvister, 4 October 2014)

Figure 10 (b) shows a car crashed into concrete wall and caused two people died from the family at km 256 PLUS highway. The barrier is of the rigid type and its function is to redirect the vehicle upon collision where the dissipated energy will be absorbed by the vehicle and causing the metal body to deform, and sometime lead to fatal accident. It is recommended quay fender be lined to the side of concrete barrier wall at accident prone location as shown in Figure 11.

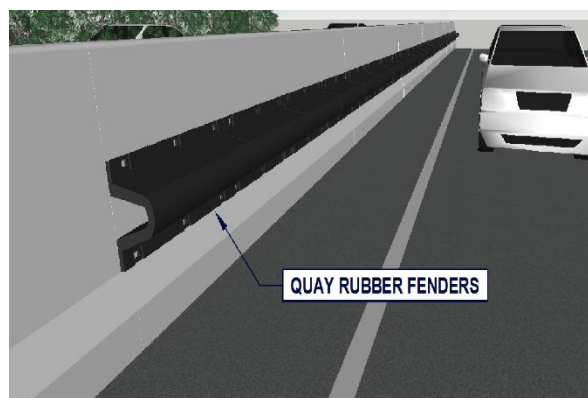
Figure 11: Quay rubber fender can be lined to the surface of concrete wall
